**Lewes BPW**  
electric, water and sewer utility

# **ROOT CAUSE REPORT**

## **DECEMBER 2019 WWTF**

### **FAILURE AND DISCHARGE**

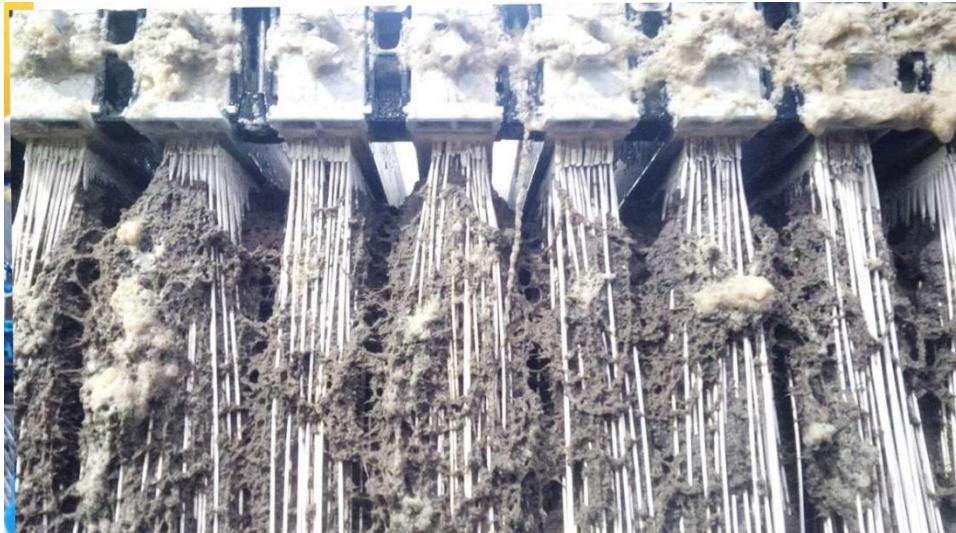
Suez would do routine consultation on the performance of the filters. The last review by Suez was March 2017. During that inspection Suez recommended to WMES that the filters had accumulated significant amounts of solids which were interfering with the effectiveness of the automatic backwashes and operation of the filters and that the filters be mechanically cleaned. (Picture 1)

**Picture 1 Debris Loading Suez Report 2017**

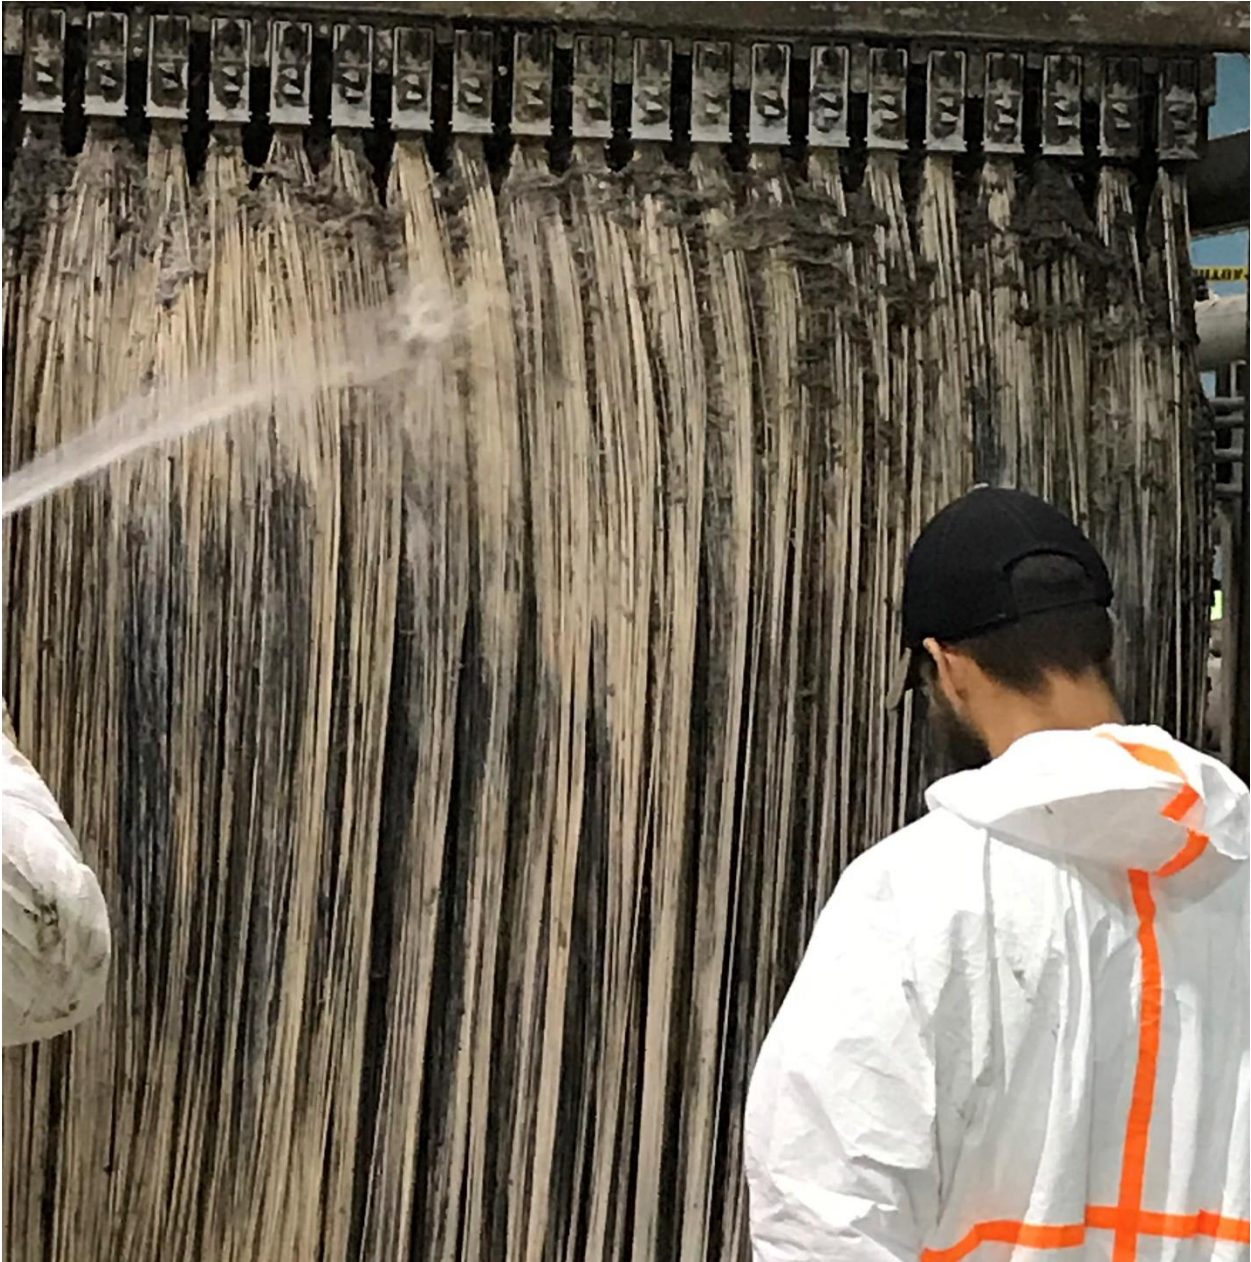
- ▶ Mechanical cleaning of filters starts (Picture 2)

► Picture 2 – Condition of filters as cleaning starts in December 2019

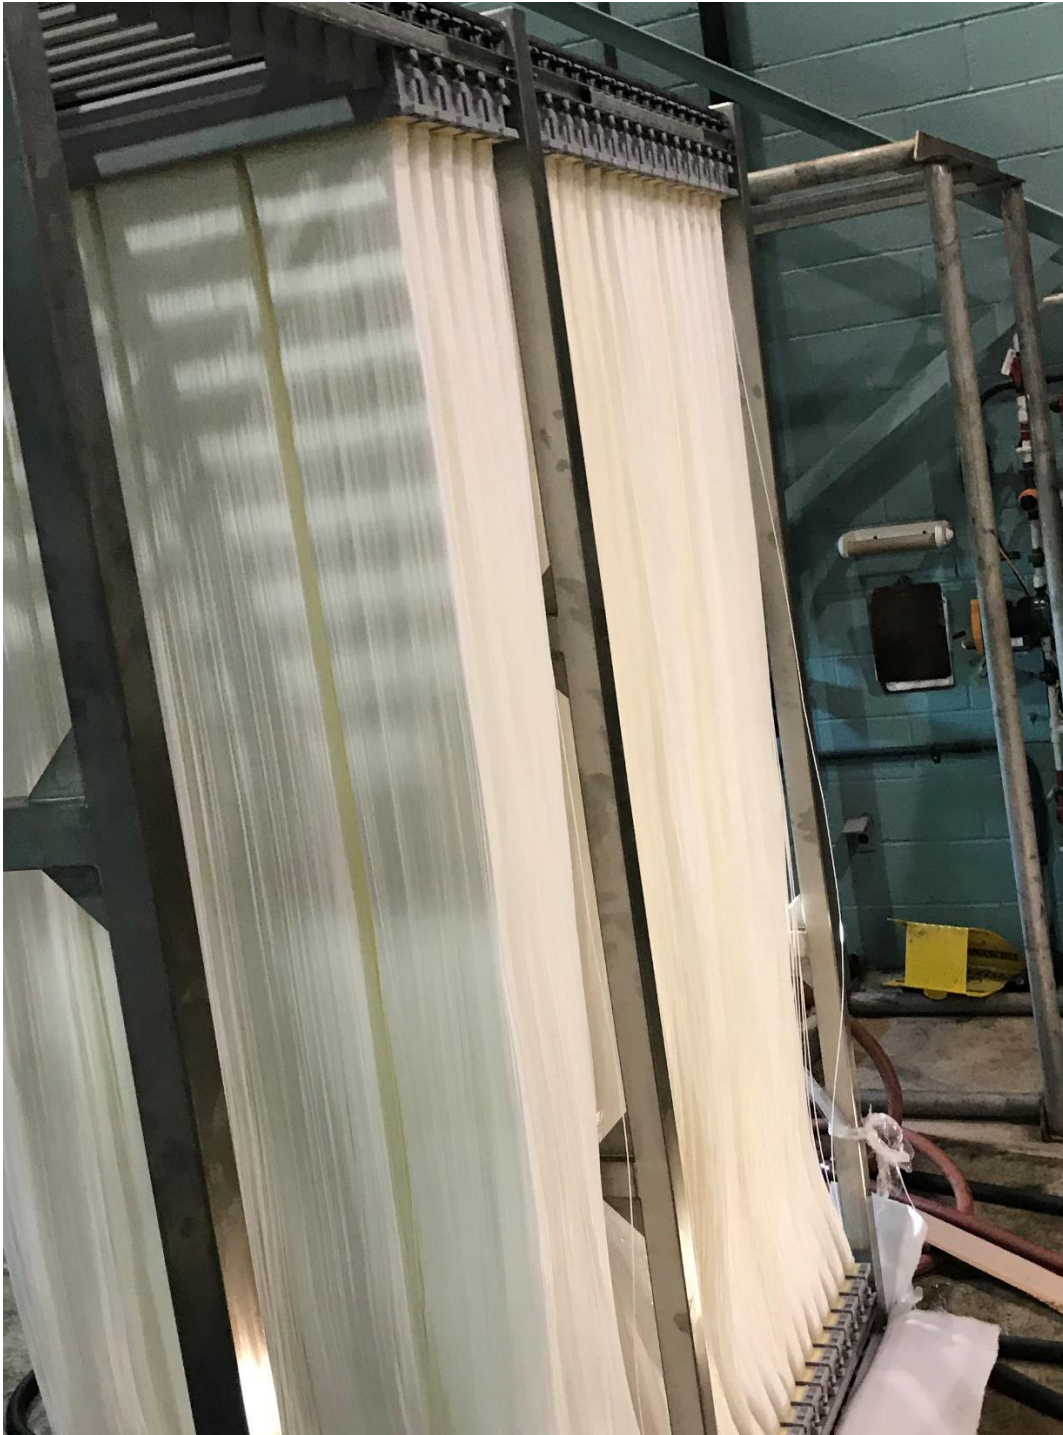
- ▶ First train of new membrane is received and installed (Picture 3)

**Picture 3 – New Membrane Loaded into Cassettes – December 2019**

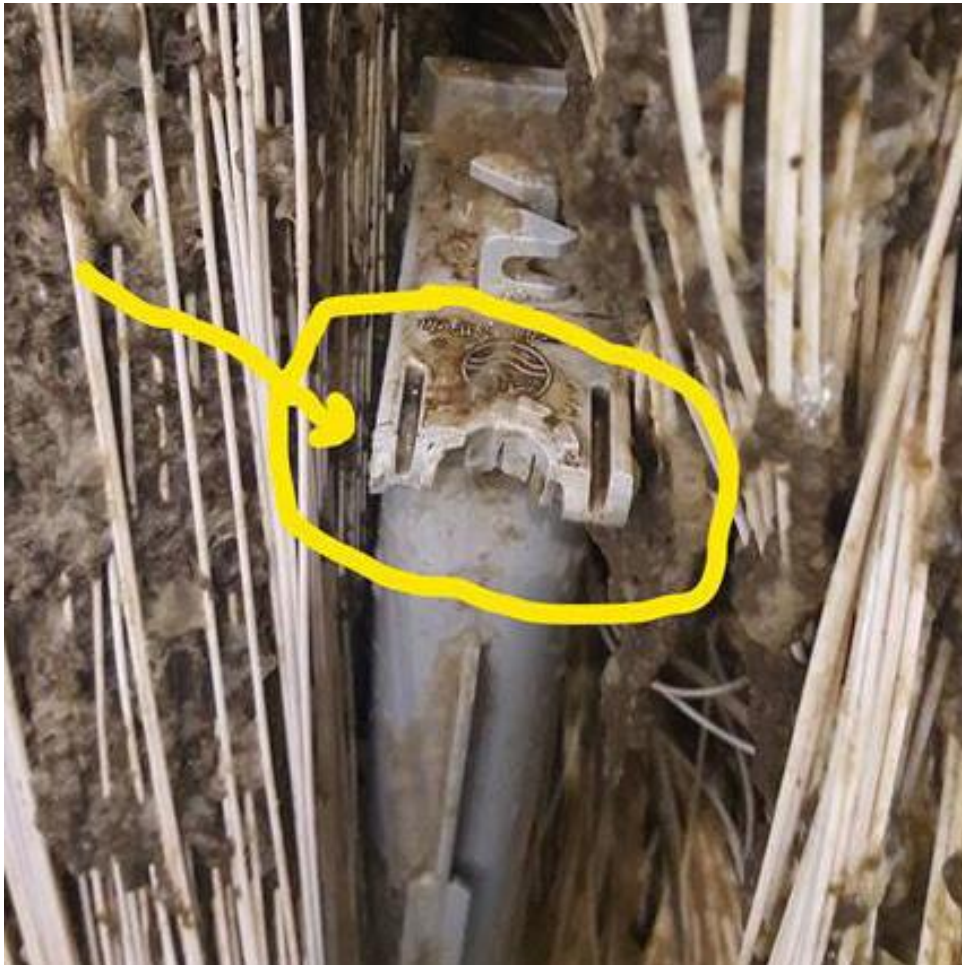
- ▶ BPW was notified of failure and repair.
- ▶ WMES Suspect module was pulled. Pictures indicate high level of sludge accumulation in the cassettes
- ▶ Failure was a break in the lower header, blank installed and cassette returned to services (Picture 4)

**Picture 4 – Lower Lock Tab Break and dislocated header, April 2019**

Insufficient monitoring of the membrane condition and proactive maintenance/cleaning by WMES led to physical over-stressing resulting in the mechanical failure of the lower header locking tab.

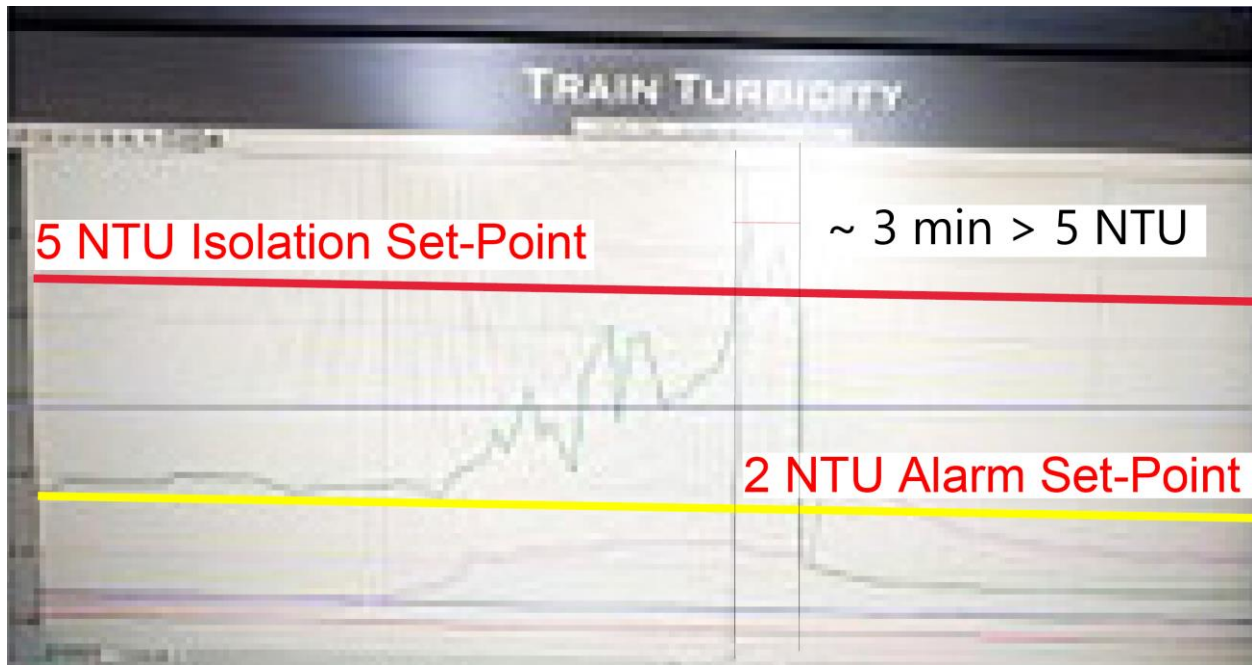
The filters are designed to detect and isolate themselves in the case of a break in the membranes or any contamination of the permeate tank water. The Turbidity Meter set-points were supposed to be set at 2 NTU to alarm and 5 NTU to isolate. During Suez's site visit in January 2020, the isolation set-point was initially found to be set to 10 NTU (top of scale) thus removing any protective function. Upon returning to site the next day, Suez found the set-point had been returned to its correct settings. This indicates that WMES knew the correct set-points.

The correct set-points would have prevented the contamination of the permeate tank and resulting in the contamination of the other trains. The extent of the failure would have been limited to one cassette in one train and thus prevented the loss of the entire filter system.

Note: The needle valve plugging did not contribute to the failure of December 2019. In reviewing the log data, it is clear that the turbidity meter was operating through the event and only plugged after there was gross contamination of the permeate. The Turbidity in Train # 3 was above the Isolation set-point of 5 NTU for over 3 minutes. The system should have isolated within 10-15 seconds (Picture 6)

**Picture 6 – Turbidity During 19 December 2019 Event**

1. Replace all four trains of filter membranes  
**Status:** Two trains have been installed and the remaining two have been ordered and will be installed by no later than the beginning of May 2020 in advance of the Memorial Day weekend
2. Reset Turbidity set-point to Manufacture recommended setting  
**Status:** Complete as of 13 February 2020

3. Replace all four Turbidity monitors with new models that have additional functionality, including the ability to alarm on loss of flow.
