September 30, 2020

**RE: Wetland Impact Assessment for December 2019 Bypass Event, City of
Lewes Wastewater Treatment Facility**

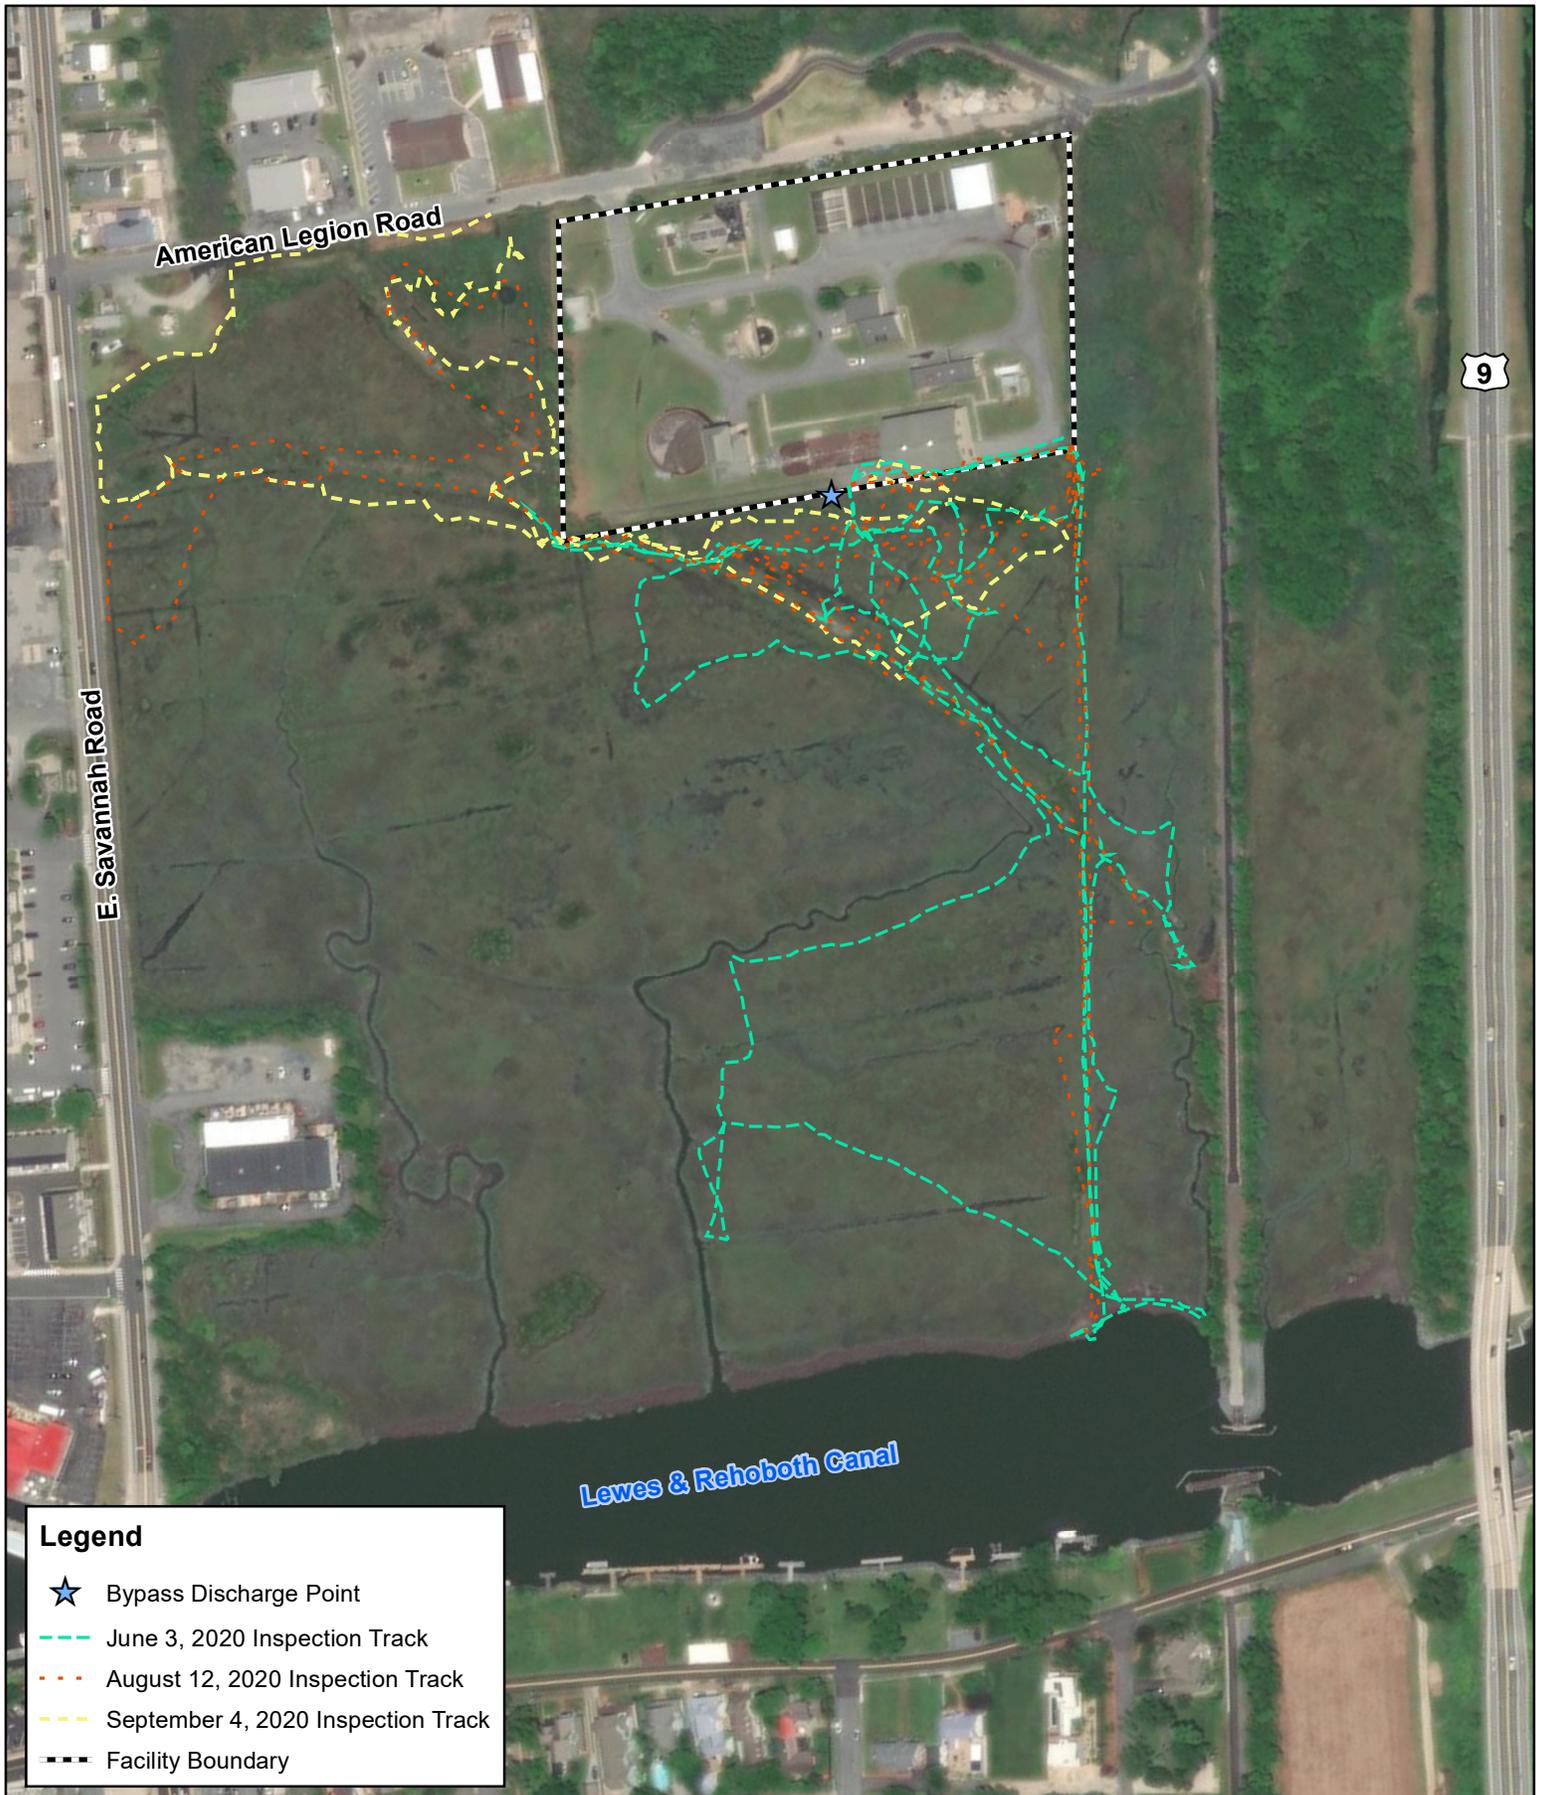
Figure 2 - Pedestrian Survey Routes
City of Lewes - Wastewater Treatment Facility
Sussex County, Delaware

Early and mid-season inspections of the potentially affected wetlands were performed by the author on June 3, 2020 and August 12, 2020, respectively. A brief follow-up to the mid-season visit was performed on September 4, 2020. All inspections were conducted at low tide when the marsh surface was not inundated except for standing water in closed depressions. Figure 2 depicts pedestrian survey routes for each inspection date.

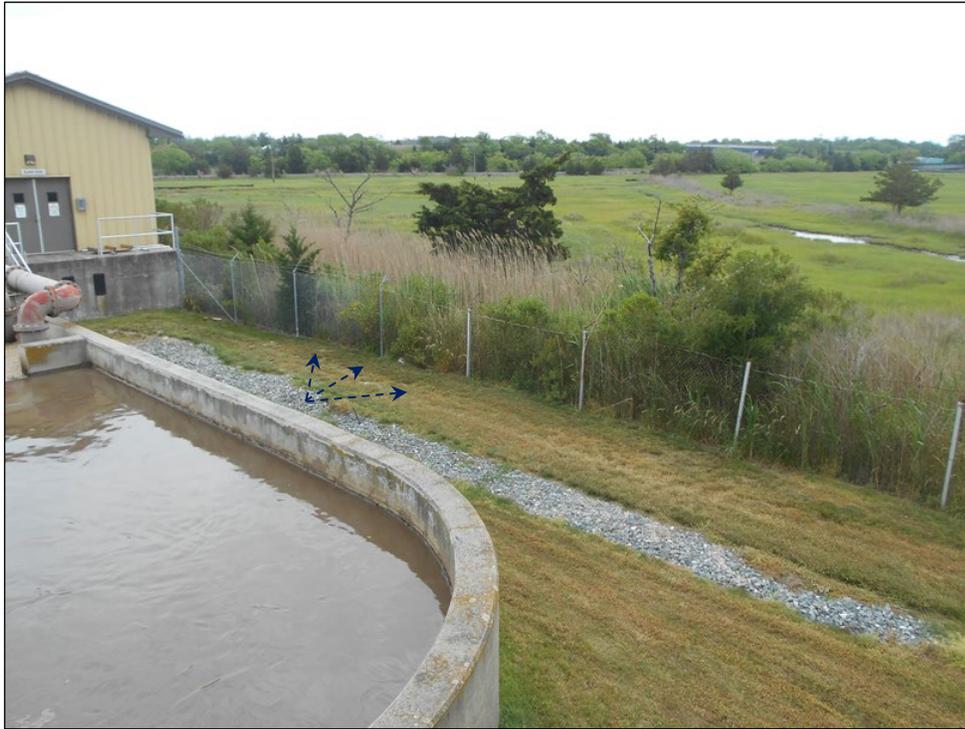
Photo 1. General location of bypass discharge into gravel swale along south fence line of WWTF where effluent then flowed overland into adjacent tidal salt marsh in Area A. (June 3, 2020)

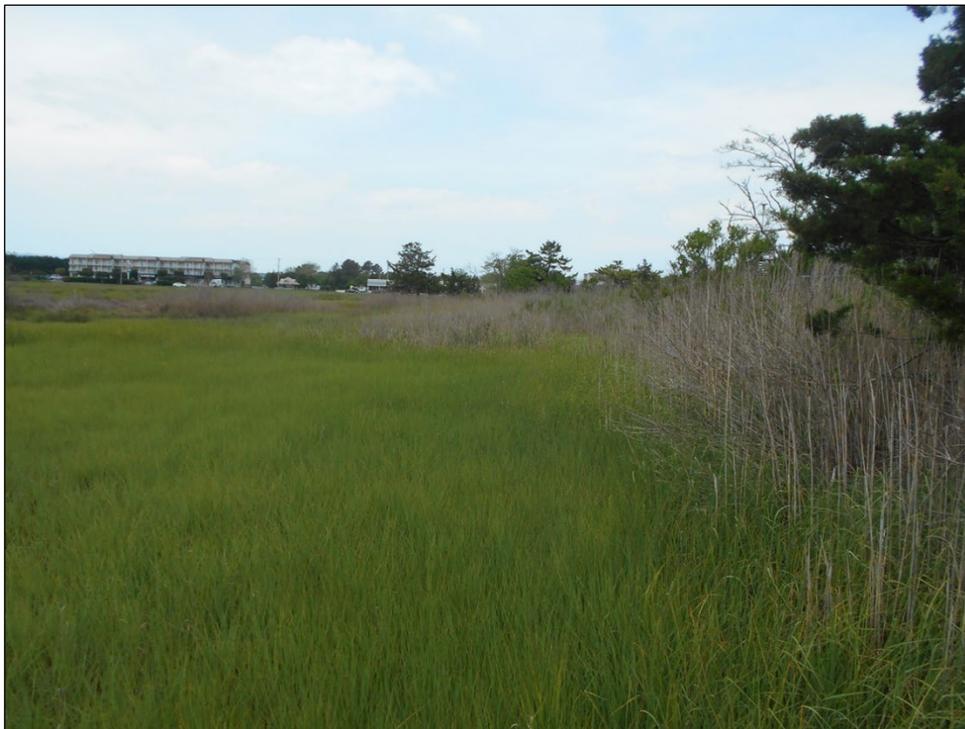
Photo 2. Healthy *Spartina alterniflora* low marsh bordering south side of WWTF near bypass discharge entry point into Area A. Note dead wetland shrubs and *Phragmites*. (June 3, 2020)

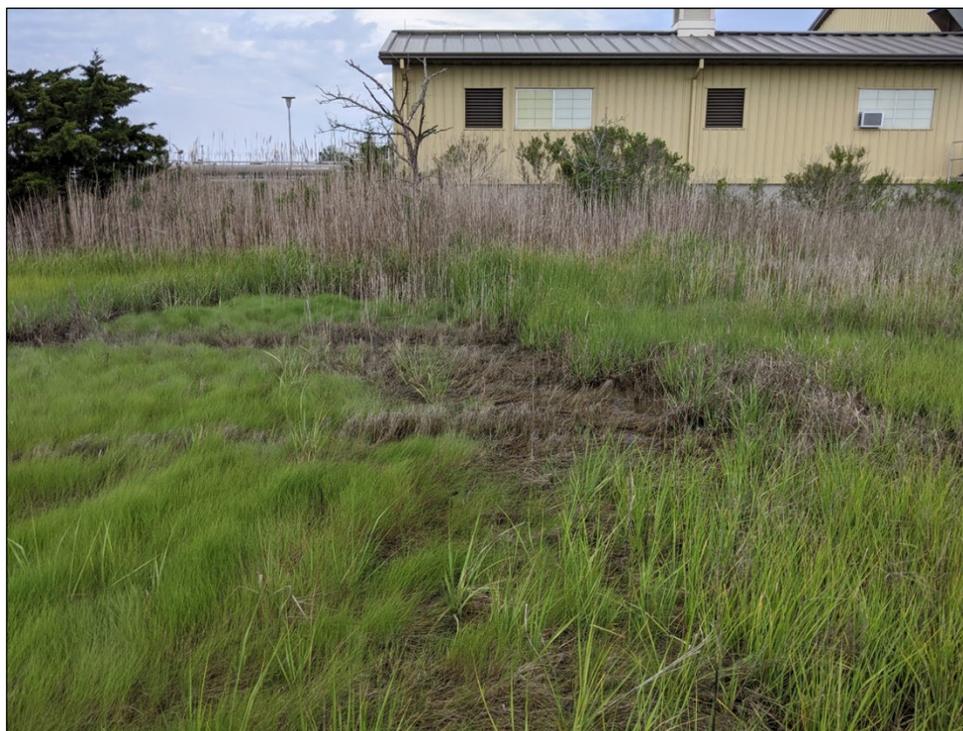
Beyond the sparsely vegetated low marsh areas, there were no indications of widespread vegetation impact in Area A during the June site visit. A few localized instances of discolored (browning) vegetation and potential die-back affecting high marsh species were observed along the high marsh-low marsh interface. Die-back was no longer visible in most of these areas by August except where noted otherwise. Where dead plants were still visible in August, evidence of regrowth was often present with the exception of a few small areas that may be undergoing species shifts associated with conversion of high marsh to low marsh presumably in response to sea level rise.

Photo 3. Dead high marsh vegetation in Area A at high marsh-low marsh transition. (June 3, 2020)

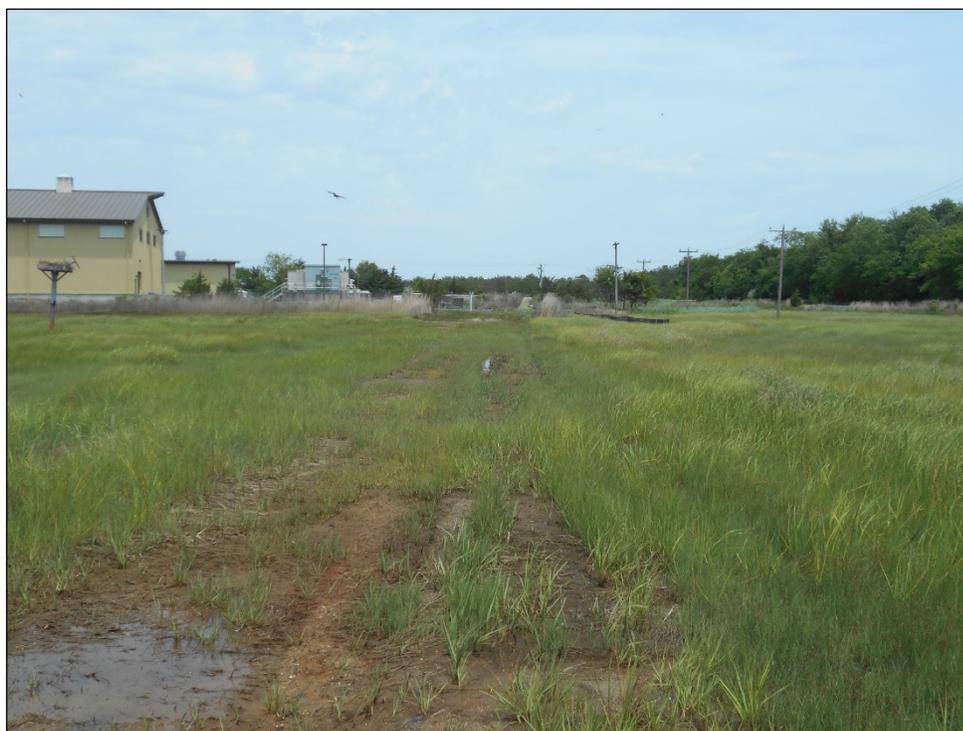
Photo 4. Backfilled discharge pipe trench in utility corridor separating Area A (left) and Area B (right). (June 3, 2020)

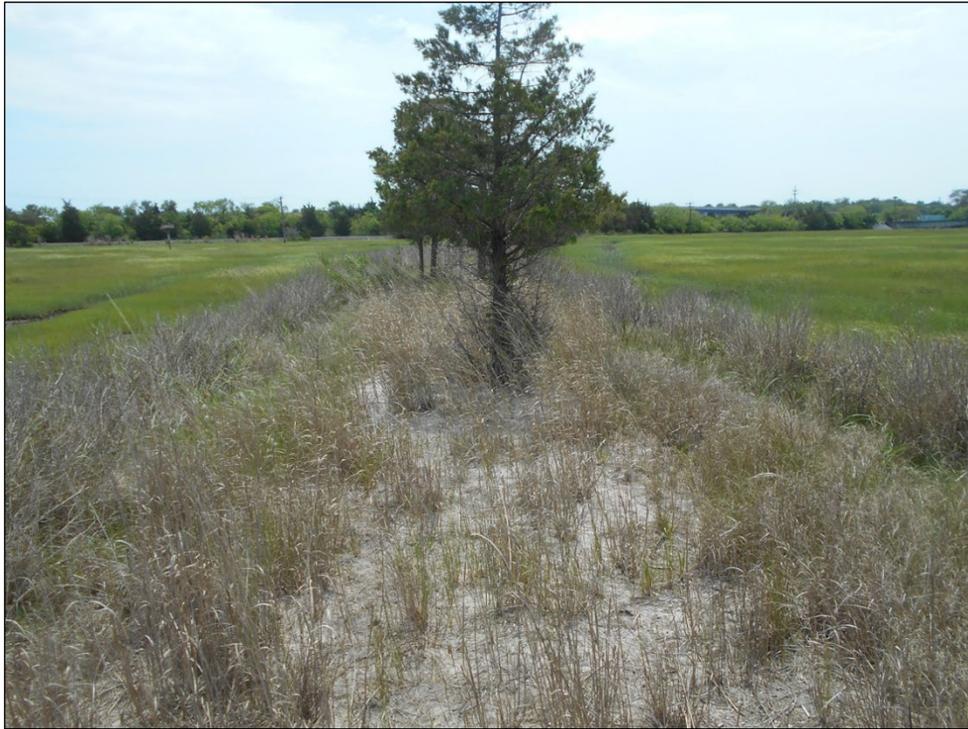
During the June site visit, most wetland shrubs growing along the margins of the railbeds in Areas A and D appeared dead or still dormant, though adjacent tall form *Spartina alterniflora* appeared healthy and normal. A few shrubs exhibited die-back with limited amounts of patchy growth. Wetland shrubs along the wetland-upland transition bordering the WWTF, possibly at slightly higher elevations, exhibited greater amounts of live vegetation, but new growth was still patchy. Some additional growth was evident when these areas were revisited in August, but most shrubs appeared dead.

Photo 5. Remnant of historic railbed separating Area A (left) and Area D (right). Note dead wetland shrubs along each side at margin. (June 3, 2020)

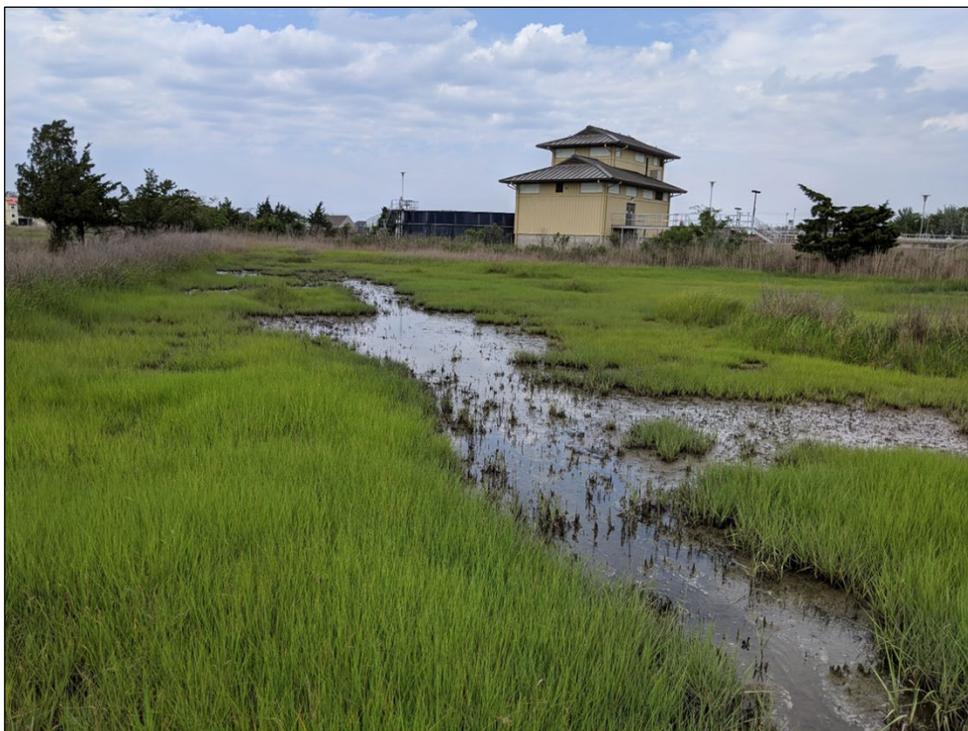
Area A (as well as the other areas) contains evidence of historic ditching including remnant spoil piles (slightly elevated circular mounds) as well as linear ditches, most of which have filled with sediment and partially, if not completely, revegetated. Portions of a remnant ditch in Area A running parallel to the railbed were sparsely vegetated containing stunted *Spartina alterniflora* or stubble and *Salicornia virginica* (glasswort, pickleweed). These linear depressions were determined to be poorly drained remnants of historic ditches. Poor drainage of marsh soils can lead to water-logging, which is known to stunt and eventually eliminate plant growth. Unless widespread, such features are generally not problematic since they contribute to microhabitat diversity (e.g., pools and pannes), create additional edge habitat, and provide important foraging habitat and low-tide refugia for wildlife. The sparsely vegetated features in Area A and elsewhere are clearly visible on aerial photos taken prior to the bypass event. Similar areas of stunted low marsh vegetation including dead or dying *Spartina alterniflora* or stubble were also observed in poorly drained features within Area D including sites closer to Area A and sites farther away not located on a connecting flow path.

Photo 6. Remnant mosquito ditch in Area A. Note sparse low marsh vegetation and stubble as a result of waterlogging due to poor drainage. (June 3, 2020)

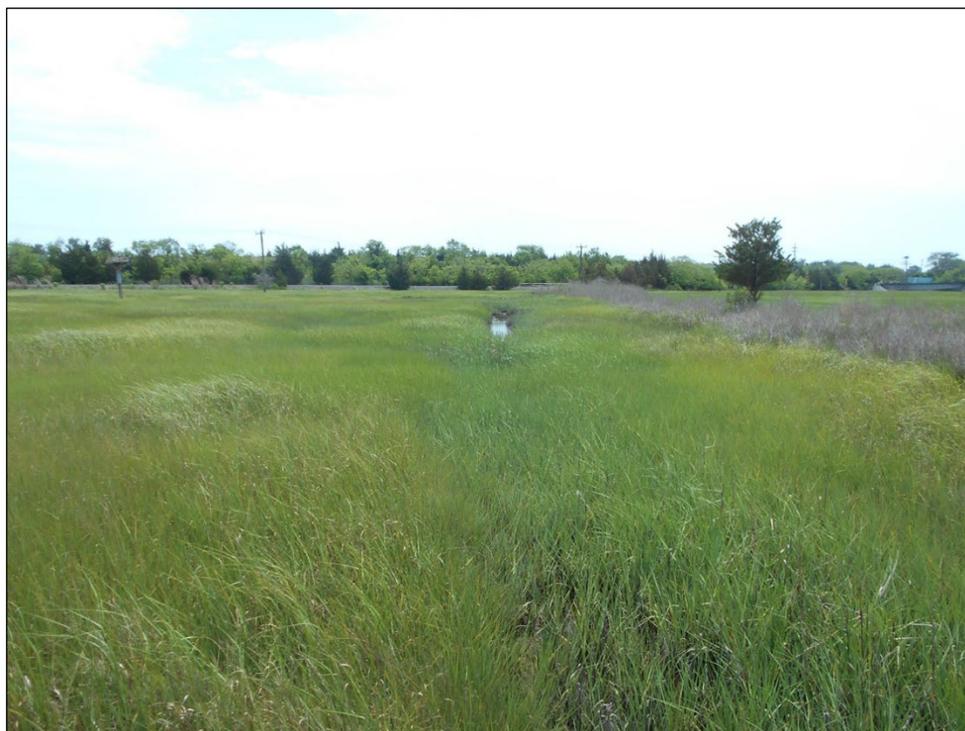
Photo 7. Healthy *Spartina alterniflora* low marsh and remnant mosquito ditch in Area A along flow path to Area D. Note dead wetland shrubs along railbed. (June 3, 2020)

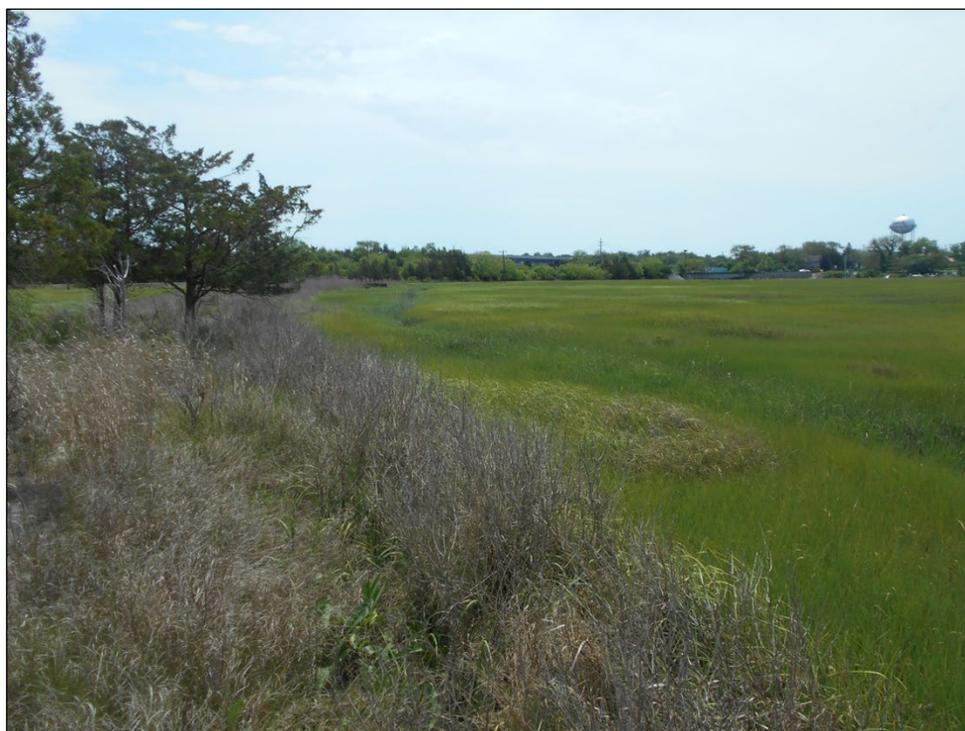
Photo 8. Healthy *Spartina alterniflora* low marsh and dead wetland shrubs along railbed in Area D. (June 3, 2020)

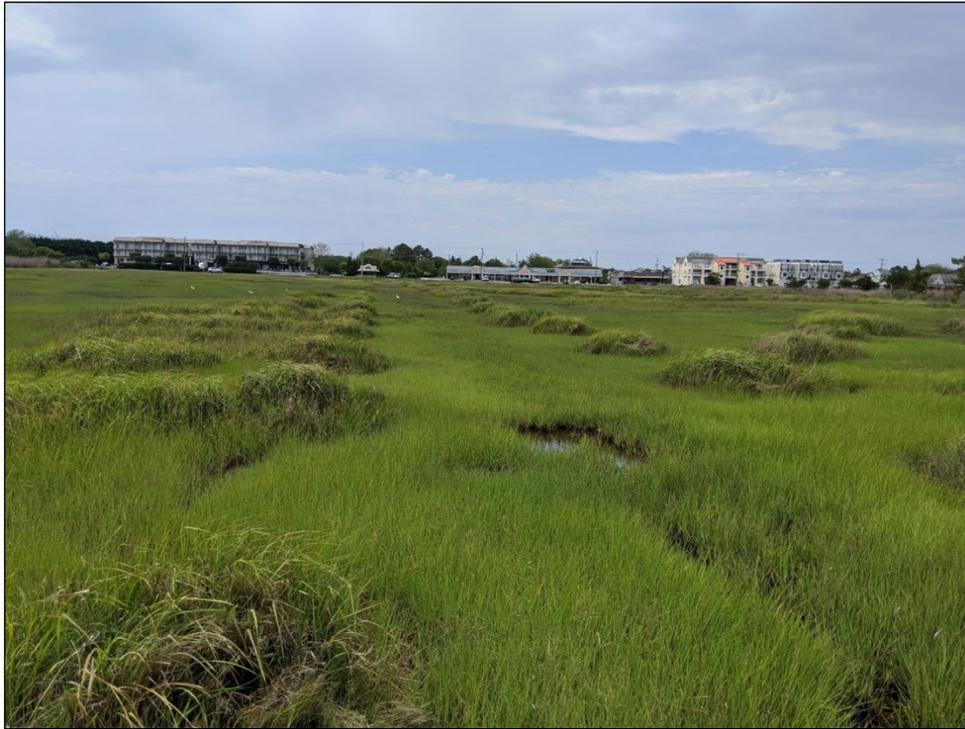
Photo 9. Relic spoil mounds along revegetated former mosquito ditch in Area D looking towards Savannah Road. Note egrets foraging on marsh. (June 3, 2020)

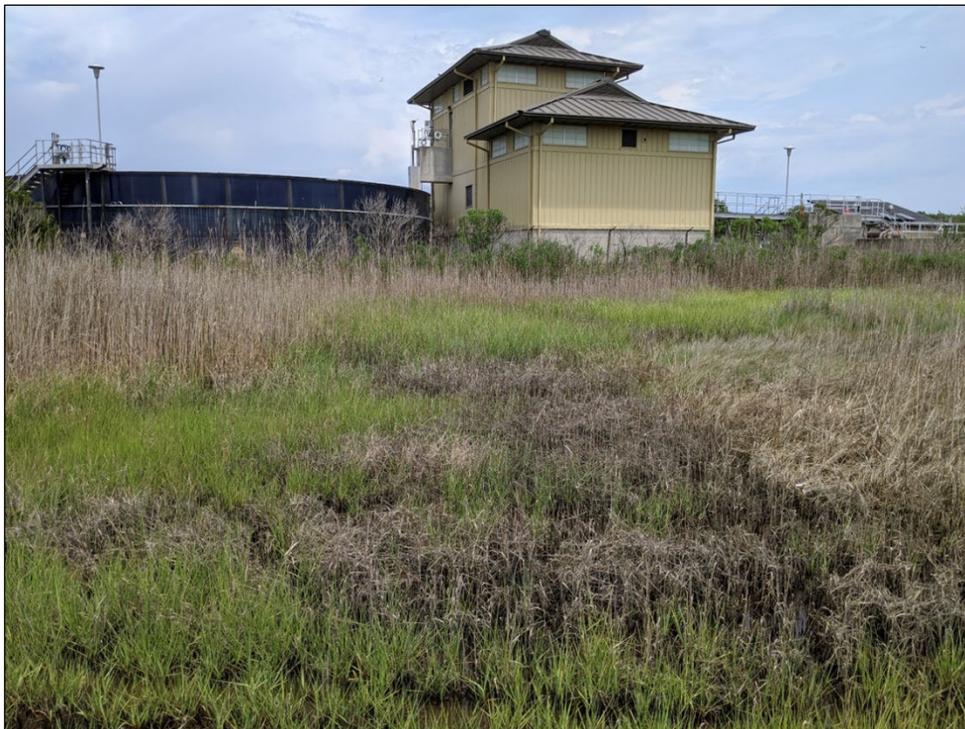
Photo 10. Northernmost gaps in railbed between Area A (background) and Area D (foreground). Note die-back of *Spartina alterniflora* in opening due waterlogging/poor drainage. (June 3, 2020)

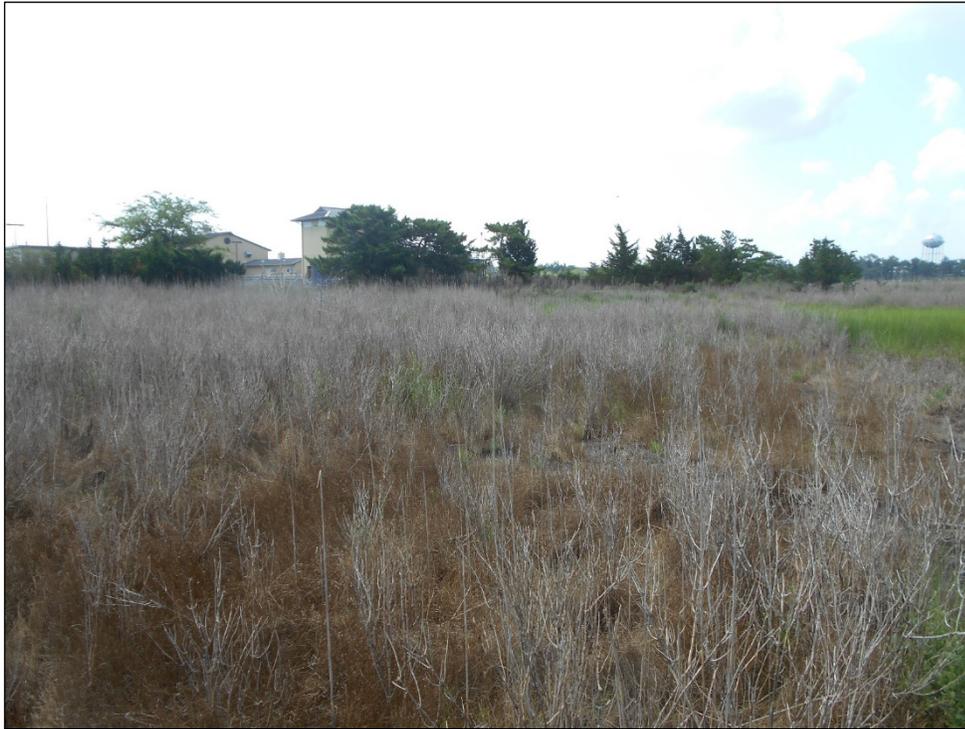
A correlation between dead and partially dead wetland shrubs and dead *Phragmites* (standing dead stems) was noted throughout the assessment area. This phenomenon was most prominent within Areas E, F, and A along the border with the WWTF, and to a lesser extent along the railbed on the north side of Area D. Notable, most such areas exhibited little to no regrowth of *Phragmites* (new green stems). Where limited (stunted) *Phragmites* regrowth was observed, shrubs tended to be at least partially alive still. In a few locations, full-height *Phragmites* with tasseling seed heads was present in August and September intermixed with wetland shrubs that appeared healthy and normal. It was subsequently learned that the City of Lewes has embarked on a *Phragmites* eradication program that includes burning, spraying, and mowing. The area around the WWTF was treated with herbicide by aerial and ground application in August 2019 (Darrin Gordon, pers. comm.). No evidence of burning or mowing was observed; however, impacts to wetland shrubs were consistent with collateral damage to non-target vegetation resulting from use of a non-selective herbicide such as glyphosate, which is commonly used to treat *Phragmites*.

Photo 11. Dead wetland shrubs (*Iva frutescens*) and high marsh herbaceous vegetation (*Juncus gerardii*) in Area F. Note dead *Phragmites* stems and patch of health low marsh on right. (August 12, 2020)

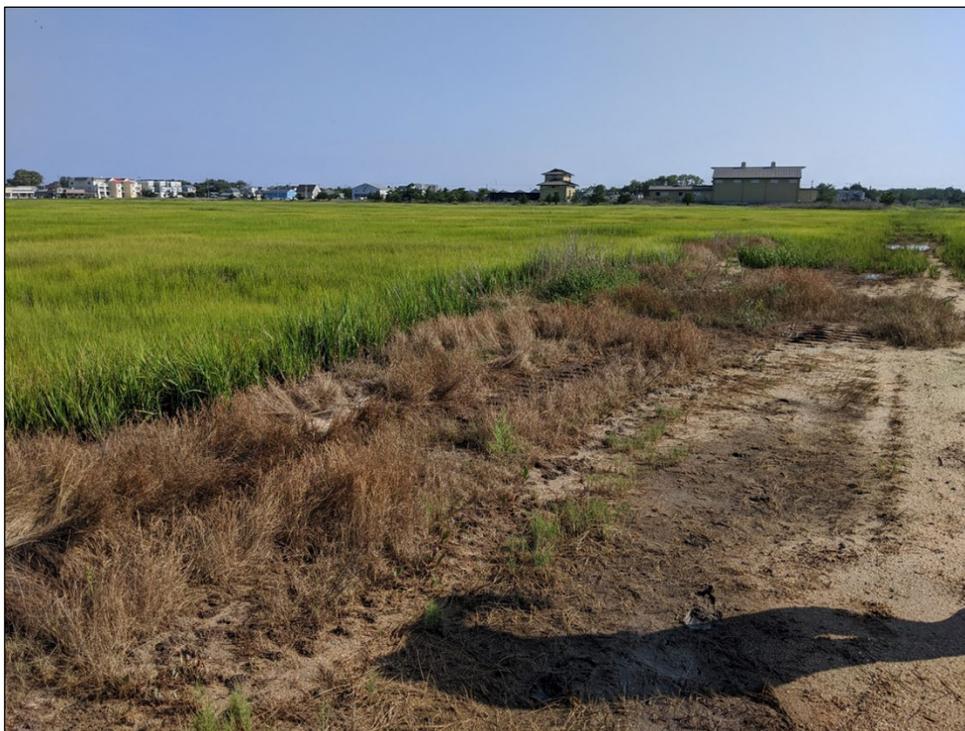
Juncus gerardii prefers non-saline, waterlogged soils, and while not particularly sensitive to drought, research has shown it to be intolerant to flooding (Watson et al. 2015, Charpentier et al. 1998, Rozema et al. 1985). Differential tolerance/response to salt water flooding among *Juncus gerardii*, *Spartina patens*, and *Distichlis spicata*, all of which occupy similar niches within the high marsh, could explain the loss of the former with little apparent impact to the latter two. Coastal flooding associated with the remnants of Hurricane Isaias, which impacted the area one week before the August site visit, or similar events could have triggered such a response. Differing sensitivity to herbicide overspray could also explain this response. The absence of any recognizable spatial pattern or gradient associated with *Juncus gerardii* impacts, as well as its vertical position above the regularly flooded low marsh, which would have had more direct, prolonged exposure to partially treated effluent, suggest that impacts to this species are unrelated to the bypass event.

Photo 12. Dead *Juncus gerardii* along utility corridor separating Area D (left) and Area C (right). (August 12, 2020)

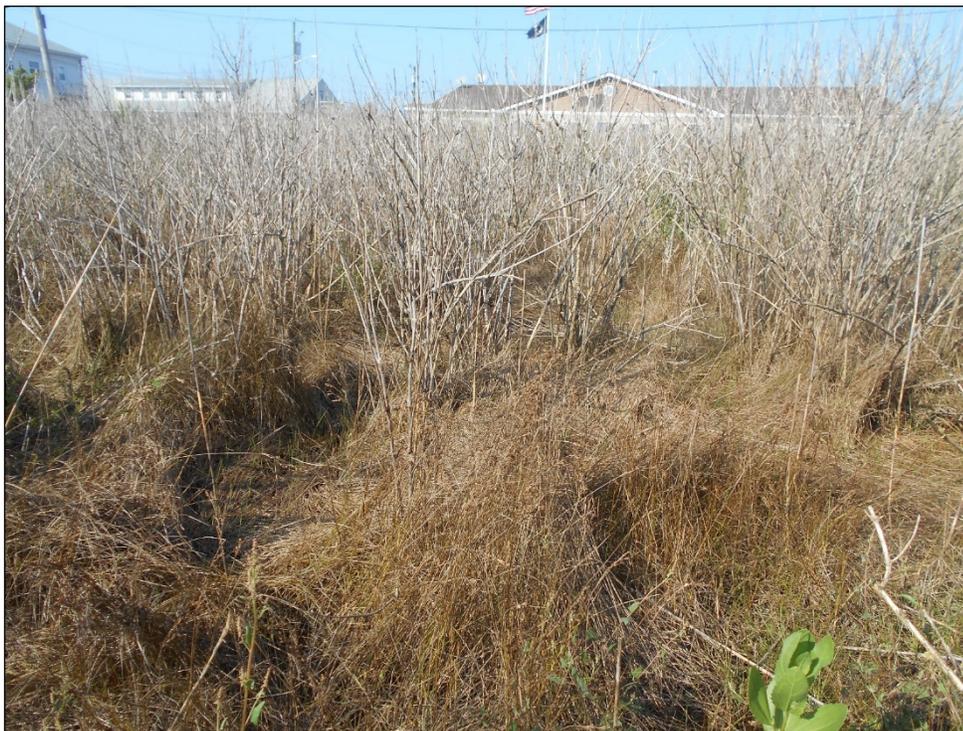
Impacts to *Juncus gerardii* growing in and around wetland shrubs are not believed to be related to herbicide treatment. If so, *Spartina patens* and *Distichlis spicata* growing with *Juncus gerardii* is expected to have been affected as well. However, both species, while less prevalent than *Juncus gerardii*, appeared normal and healthy. Additionally, a large area of dead *Juncus gerardii* was observed in Area A along the south side of the WWTF in August. While some *Phragmites* was present along the upland border, *Juncus gerardii* extended into the high marsh well beyond the band of *Phragmites* at the upland edge. This particular patch of *Juncus gerardii* appeared healthy during the June site visit, as did this species elsewhere in the assessment area. Furthermore, *Distichlis spicata* intermixed with *Juncus gerardii* in this patch appeared normal in August and September.

Photo 13. Dead *Juncus gerardii* under dead wetland shrubs in Area F. (September 4, 2020)

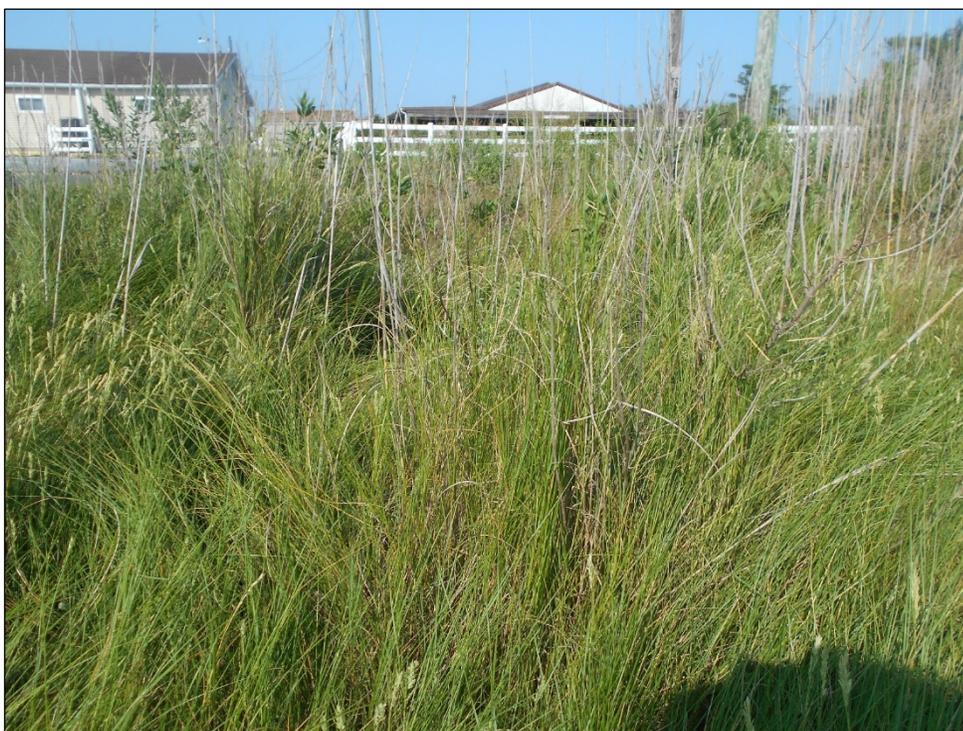
Photo 14. Live *Spartina patens* and *Distichlis spicata* under dead wetland shrubs and *Phragmites* in Area F. (September 4, 2020)

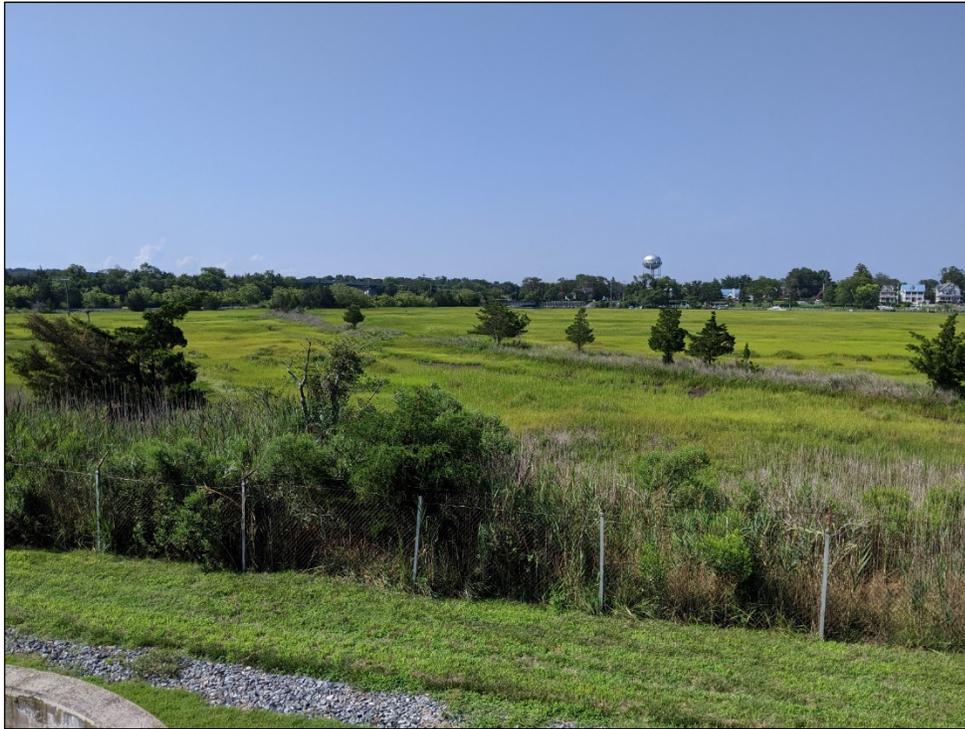
Photo 15. Area A near bypass discharge entry location. (August 12, 2020)

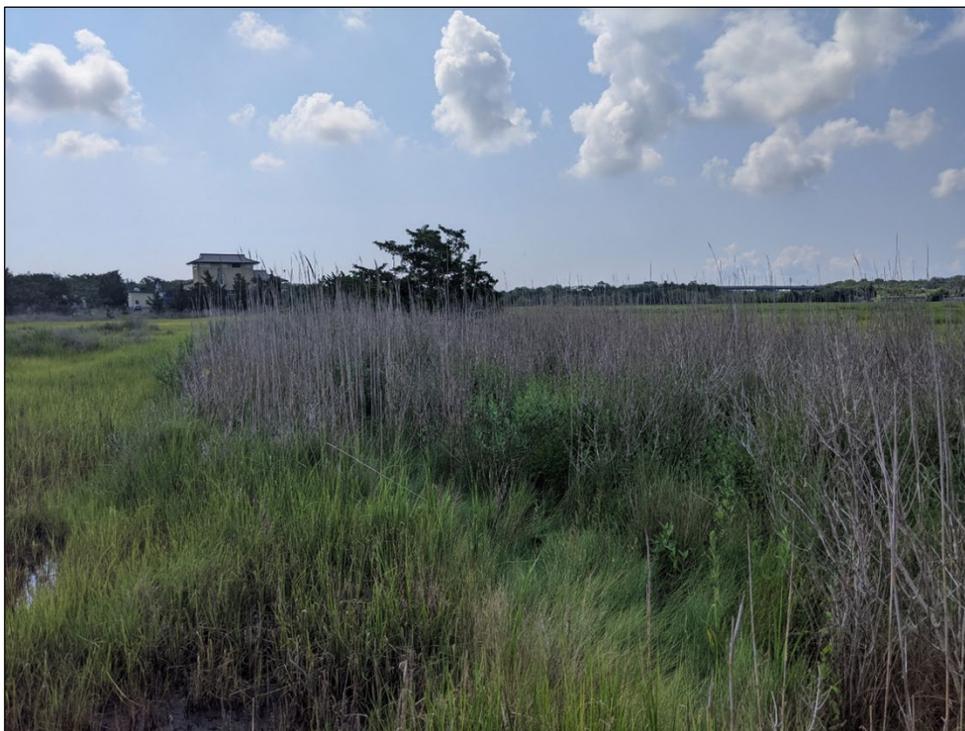
Photo 16. Dead wetland shrubs and *Phragmites* along remnant railbed separating Area E (left) and Area D (right). (August 12, 2020)

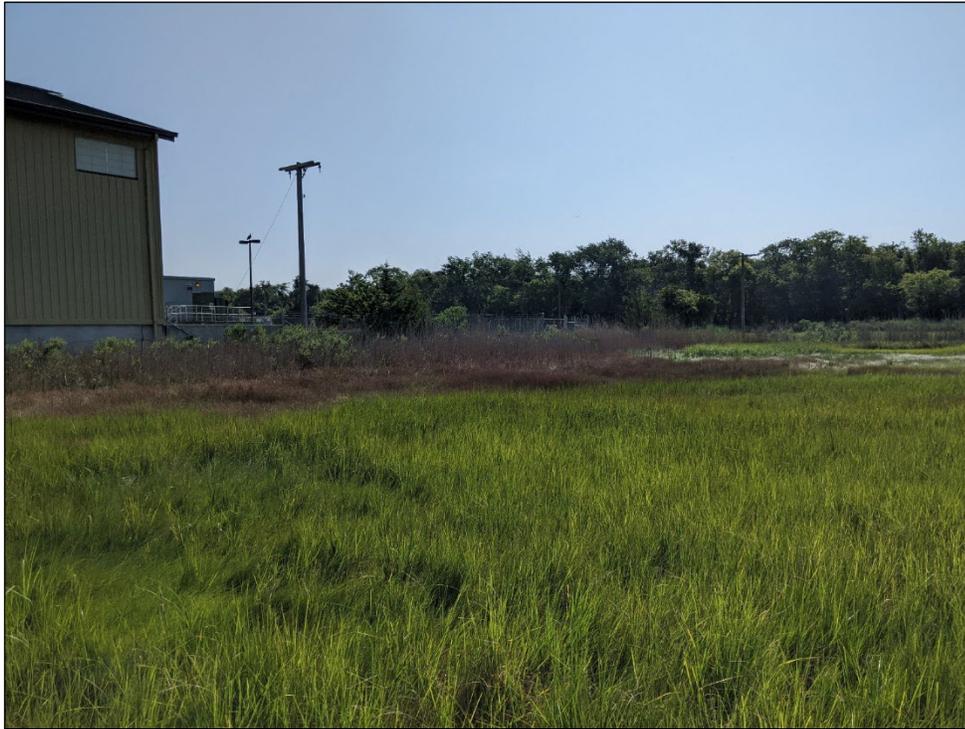
Photo 17. Patch of dead *Juncus gerardii* in high marsh near southeast corner of WWTF in August 2020. Note healthy marsh in foreground. (August 12, 2020)

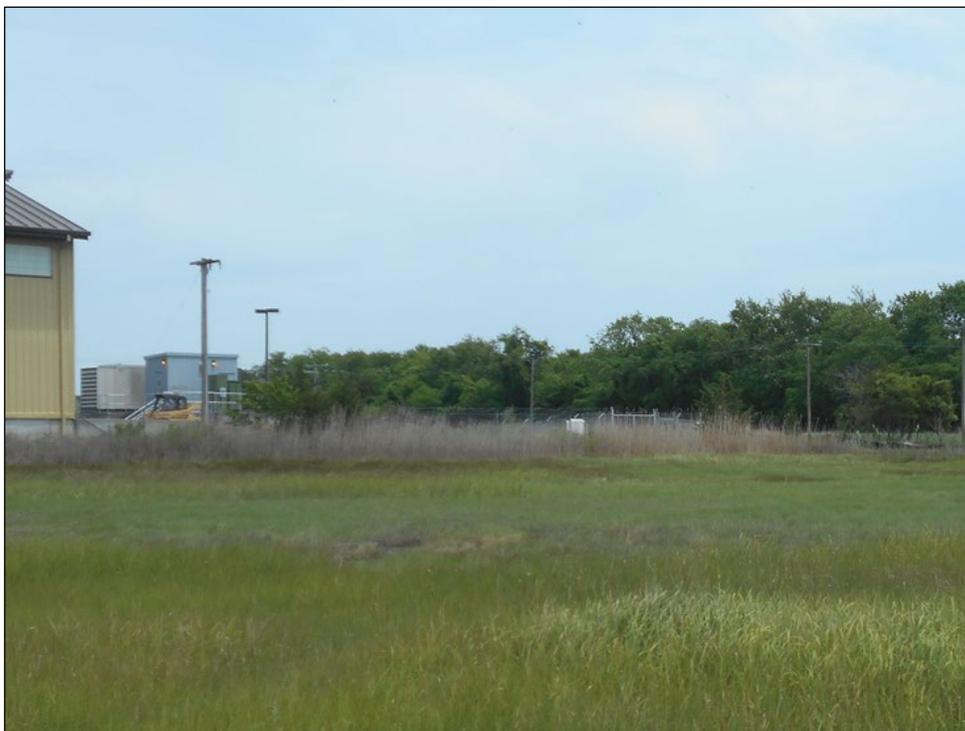
Photo 18. Same patch of *Juncus gerardii* in high marsh near southeast corner of WWTF in June 2020 with no signs of impact. Note healthy marsh in foreground. (August 12, 2020)
