# LEWES BPW

Howard Seymour Water Reclamation Plant

## **Operation and Maintenance Report**

May 2022

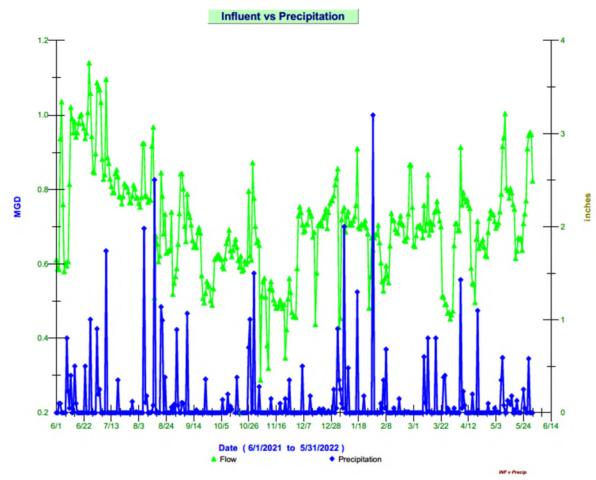
Trends Influent vs Precipitation Trend Previous 12 Months

- Please review the following tables that summarize NPDES reporting criteria for May 2022. No violations will be reported for May. The DMR will be forwarded upon completion.
- The average daily influent flow for May was 0.766 MGD with a maximum daily flow of 0.996 MGD. Precipitation totaled 2.52 inches for May with a maximum daily total of 0.6 inches.

Max	Sum
Precipitation (inches)	0.59	2.52

Influent	Limit	Average	Min	Max	Vio
Flow (MGD)		0.766	0.605	0.996	
BOD (mg/L)		146	146	146	
TSS (mg/L)		85	85	85
